# Surveying and charting the Surtsey area from 1964 to 2007

ÁRNI TH. VÉSTEINSSON

Icelandic Coast Guard, Hydrographic Department, Skógarhlíð 14, 105 Reykjavík, Iceland, arni@lhg.is

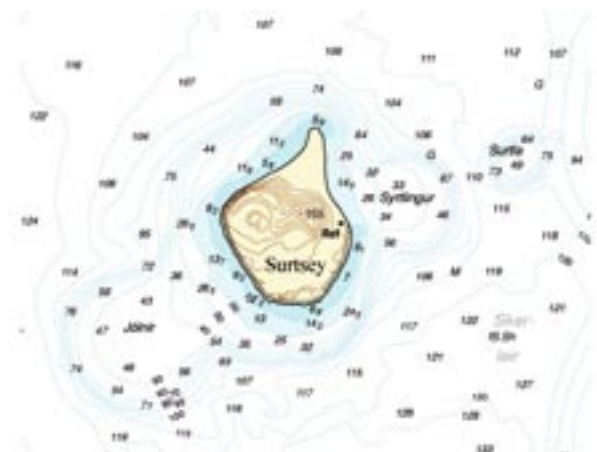
Figure 1. Surtsey as depicted on the latest edition (2002) of the chart Vestmannaeyjar, No. 321, scale 1:50,000.

ber an island had emerged from the sea 700–800 m in diameter and rising to 80 m above sea level (Fig. 1). Mariners were warned to keep clear of the area between 63°17.8'N – 63°18.2'N and 20°36.1'W – 20°36.9'W, southwest of the Heimaey island.

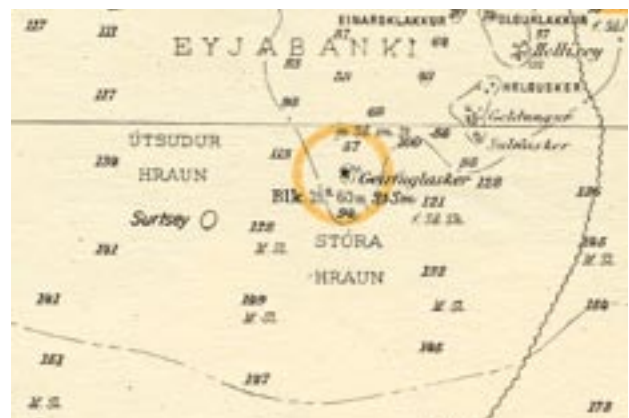
Figure 2. The Surtsey island was first shown on the Icelandic chart Dyrhólaey – Reykjavík, No. 31, scale 1:250,000, printed in January 1964

The Surtsey island was first shown on an Icelandic nautical chart printed early 1964 (Fig. 2.), only some two months after the eruption started.

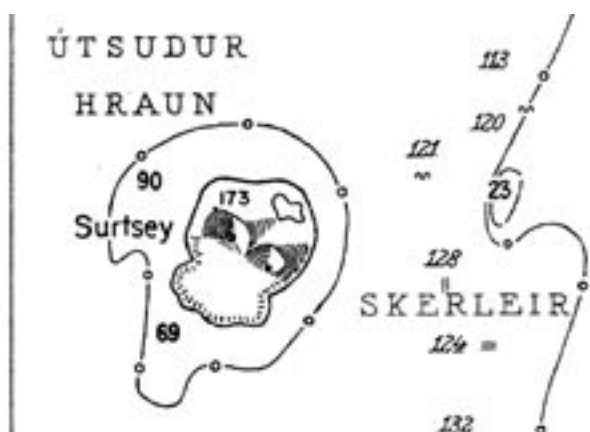
Figure 3. Part of the 1964 NM block for chart No. 33 – scale 1:100,000

After the first survey was carried out in July and August 1964 a Notice to Mariners was issued, including chart inserts (Fig. 3) for the different scale charts covering the area, showing the new island.

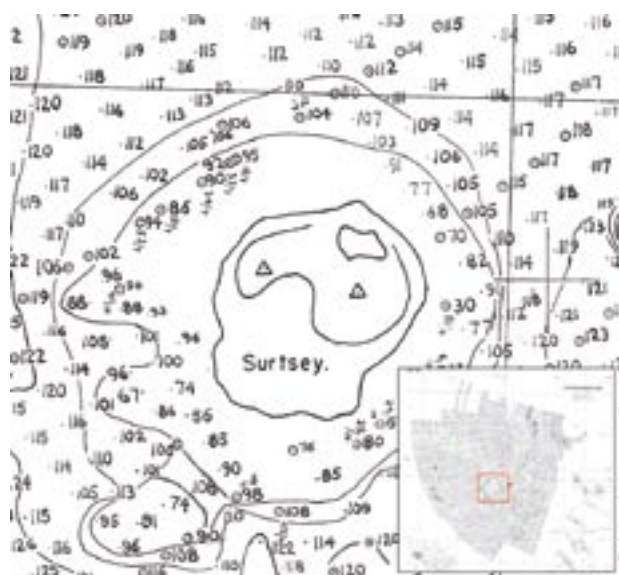
Figure 4. The 1964 survey showing depths around Surtsey.

The 1964 survey (Fig. 4) was the first echo sounder survey of the area SW of the Heimaeý island. The existing lead line survey dated back to 1901. The scale of the survey sheet is 1:40,000, giving survey line spacing of approx. 400 m (not very detailed depth information).

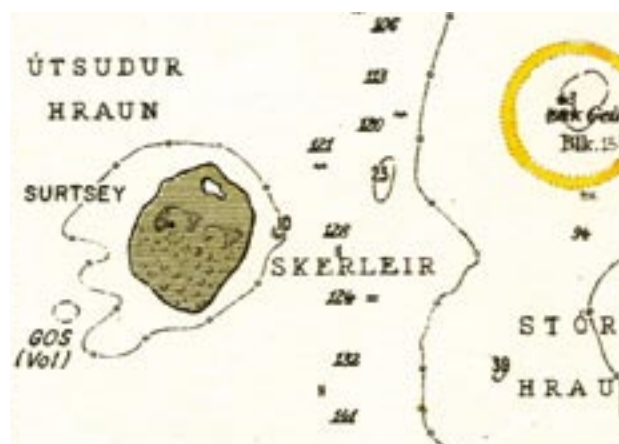
Figure 5. Volcanic activity close southwest of Surtsey as shown on the chart Vestmannaeyjar – Selvogsbanki, No. 33, in 1966.

Early in 1966 the chart Vestmannaeyjar – Selvogsbanki, No. 33, scale 1:100,000, was updated and printed showing the current status (Fig. 5) in the area around Surtsey island. Volcanic activity was ongoing close SW of Surtsey island where the small island Jólnir existed for a while. The chart bears a note: **GOS (Vol)**, “gos” meaning a volcanic eruption. Chart No. 33 is the first and only Icelandic chart (to date) to carry a note of this kind.

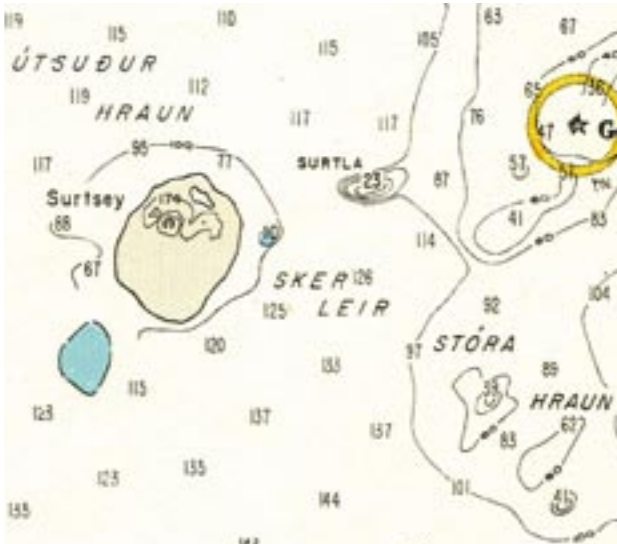
Figure 6. A cut-out from the first edition of the new chart Selvogur – Vestmannaeyjar, No. 16, published in October 1966.

In October 1966 a new Icelandic chart (Fig. 6) Selvogur – Vestmannaeyjar, part of the Coastal Chart series at scale 1:100,000, was published. Volcanic activity at Jólnir had ceased. The small island had been washed away leaving a shoal of uncertain depth shown in blue bounded by a black line.

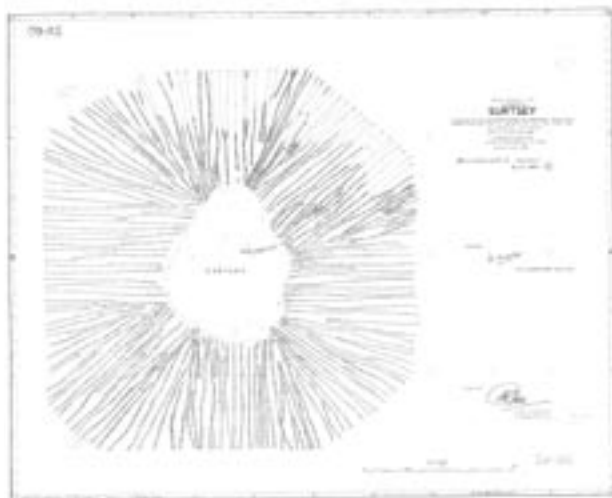
Figure 7. The 1967 survey was carried out by the crew of HMS Hecla, a UKHO survey vessel.

The Surtsey volcanic eruption came to an end in June 1967. The area was surveyed (Fig. 7) the following month by the UKHO. The 1967 survey had a varying line spacing of 40–200 m because the survey was planned in this circular star radiating manner. This gave a good picture of the configuration of the seafloor around the island.

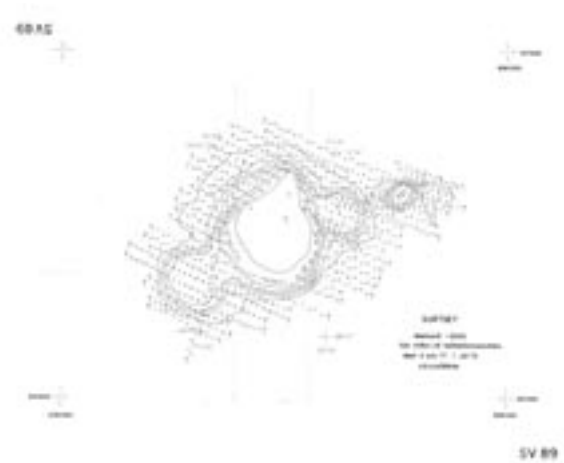
Figure 8. The 1973 survey. Least depth on the Jólnir shoal had increased from 13 m in 1967 to 28 m in 1973.

The 1973 survey (Fig. 8) was again carried out in July which is high summer in Iceland and the most likely time of the year to give a favourable weather and sea state for hydrographic surveying. The density of depth data collected was considerably less than in the 1967 survey but gives very valuable information on submarine erosion around Surtsey island between 1967 and 1973. Least depth on the

Jólnir shoal had by then increased by 15 m to a striking 28 m.

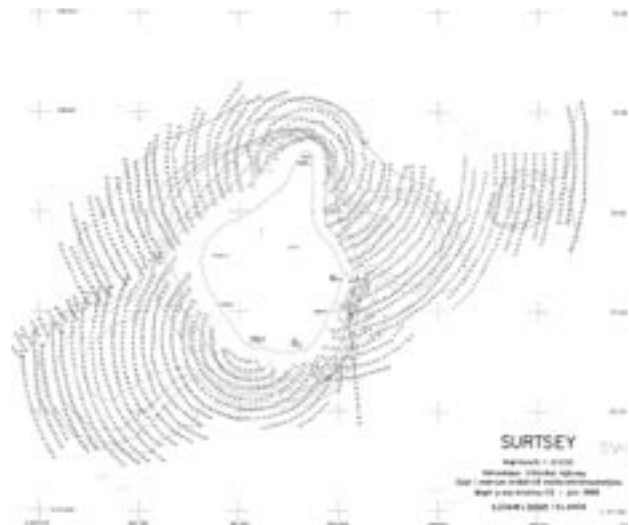
Figure 9. The 1985 survey of the Surtsey area.

The next time Icelandic hydrographic surveyors paid the island a visit (Fig. 9) was in 1985. The elements had shaped the island and its surroundings for almost 20 years. It became evident, when the soundings were plotted on the survey sheet and compared to previous survey of 1973 that the submarine erosion had continued as expected. Least depth on the Jólnir shoal had increased to 37 m.

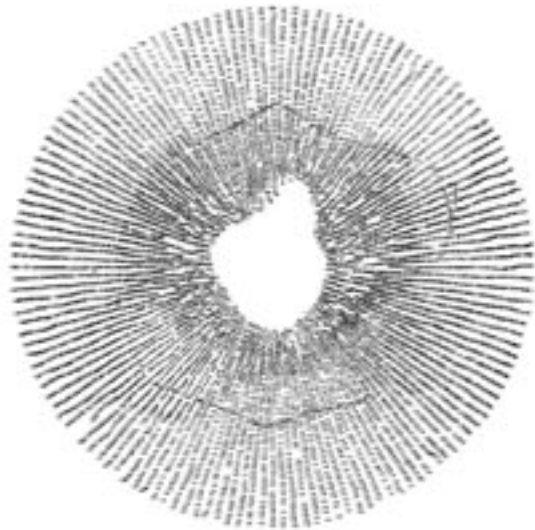
Figure 10. The July 2000 survey has a certain technical beauty, because of its circular shape.

Fifteen years passed but in July 2000 surveyors came to the island once again. The survey (Fig. 10) was planned in a circular manner similar to the 1967 survey. Least depth on the Jólnir shoal had now increased by 5 m to 42 m.

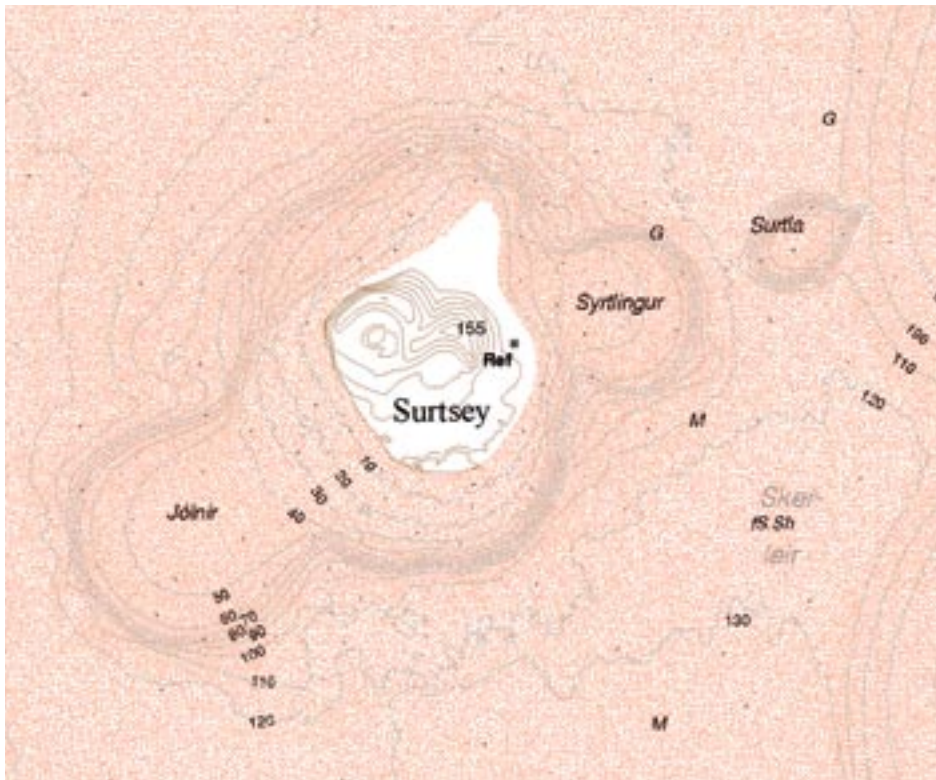
Figure 11. The 2007 multi-beam data set reduced to 20 m sounding spacing.

The latest survey (Fig. 11) was carried out in July 2007. It was the first multibeam echo sounder survey around Surtsey island (seafloor coverage

100%) and it revealed details of underwater landscape never seen before.

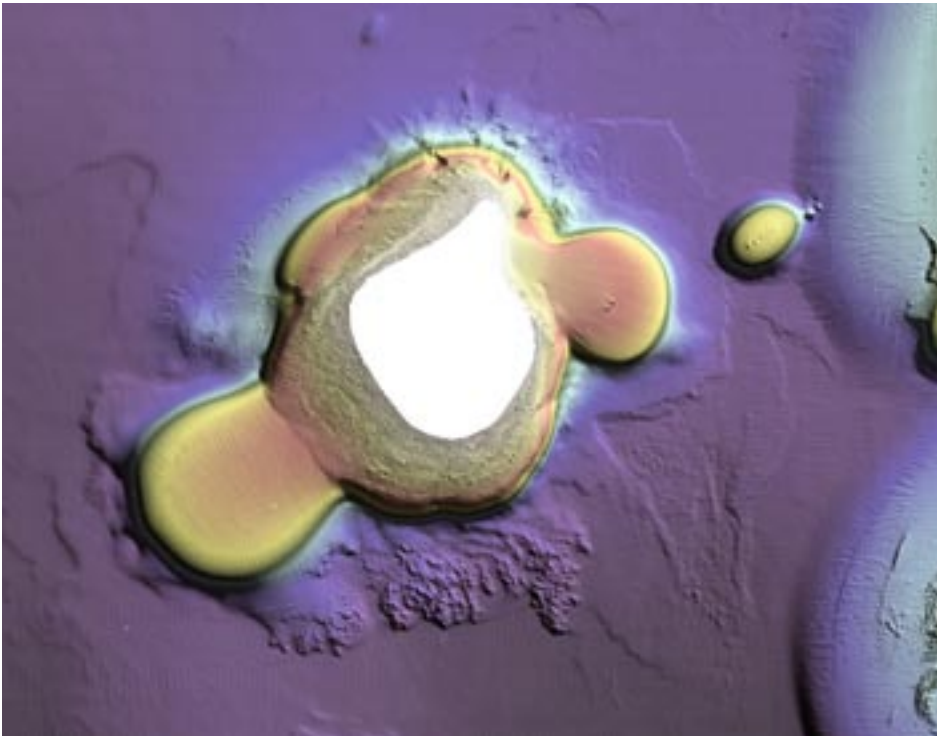
Figure 12. Sea floor image created using the 2007 multi-beam survey full data set.

The sea floor image of the Surtsey area (Fig. 12) was created using the CARIS HIPS Multibeam Professional software (a suite of bathymetry processing tools). ICG Hydrographic Department uses CARIS HIPS for processing hydrographic survey data.

The resolution of the image ranges from 2 m to 10 m in four depth zones (0–30 m, 2 m, 30–60 m,

3 m, 60–95 m, 5 m and 95 m+, 10 m). The reason for this is the fact that as depth increases the maximum possible resolution decreases. To get the most out of the sea floor image, in terms of feature detection on shallower areas around Surtsey island, this method of variable image resolution was used.

Vertical exaggeration is tenfold (10). This large vertical exaggeration creates wavelike “artefacts” most apparent on smooth surfaces e.g. like the Jólnir shoal. These artificial waves are very regular and can be differentiated rather easily from natural features. Erosion on the Jólnir shoal seemed to be slowing down as the least depth was 43 m, an increase of only 1 m the past 7 years.
